Water Districts Number 3 and 4 **(Rotterdam Junction and Pattersonville)**

Rotterdam Junction Water District #3 & 4

Lead Service Line Inventory

Pipe Identification Procedures

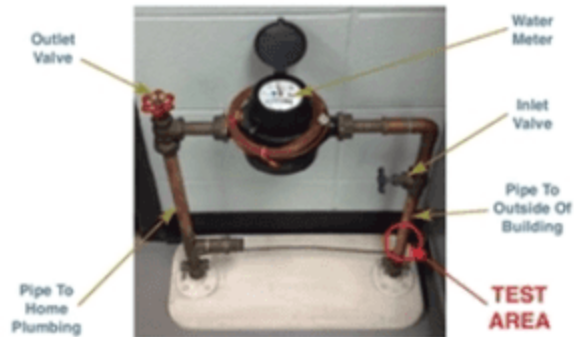
Locate the water service line coming into the building.

This is typically found in the basement. An "inlet valve" and the water meter are installed on the pipe after the point of entry.

Identify a test area on the pipe between the point where it comes into the building and the inlet valve. If the pipe is covered or wrapped, expose a small area of metal.
